# Territorial Diagnosis and Urban Sustainability Challenges in Consolidated Mixed-Use Districts: A Case Study of Kennedy Norte, Guayaquil

**Abstract**— The territorial diagnosis of the North Kennedy Citadel was developed with the aim of characterizing its current state through the analysis of five subsystems: biophysical, sociocultural, economic, human settlements and political-institutional. This area, located in the Tarqui parish of the Guayaquil canton, has a flat relief, humid tropical climate and a vegetation cover of less than 15%, affected by urban expansion. Problems such as the loss of green spaces, flood risks, traffic congestion, commercial pressure on residential land and low citizen participation were identified. Despite this, the sector has potentialities such as its strategic location, consolidated infrastructure, presence of public and private actors, and underutilized territorial resources. The methodology used was mixed, combining direct observation, informal interviews, normative analysis and statistical data processing. This diagnosis constitutes a technical basis for the design of the Partial Plan, in accordance with the cantonal PDOT and the current legal fra

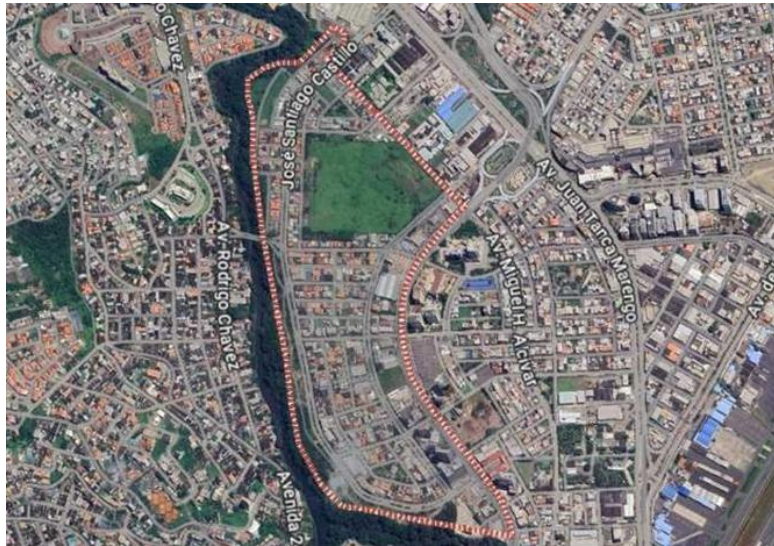
Figure 1 Delimitation of the area

The study area allows us to identify Kennedy Norte as a citadel located specifically in the city of Guayaquil with an area of 3km and a high flat relief thanks to its main roads and the use of public transport in this territory.

The Kennedy Norte Citadel is located in the Tarqui parish of the Guayaquil canton, Guayas province. It has an approximate extension of 3 km<sup>2</sup> and is located at an average altitude of 5 to 10 meters above sea level.

North: Av. Juan Tanca Marengo limitando con Av. Luis Plaza Dañín.

South: Av. Francisco de Orellana y Ciudadela Universitaria

East: Av. Miguel H. Alcívar junto al Estadio Modelo y Hospital de la Policía.

West: Av. Joaquín Orrantía, Estero Salado

The main access roads in the Cdla. Kennedy Norte son la Av. Francisco de Orellana, Av. Juan Tanca Marengo, Av. Joaquín Orrantía y Av. Miguel H. Alcívar who have public transportation, operating systems such as taxis and even has access to several stations/stops near the Metrovía (Trunk 2). Figure 3. Boundary map of the area

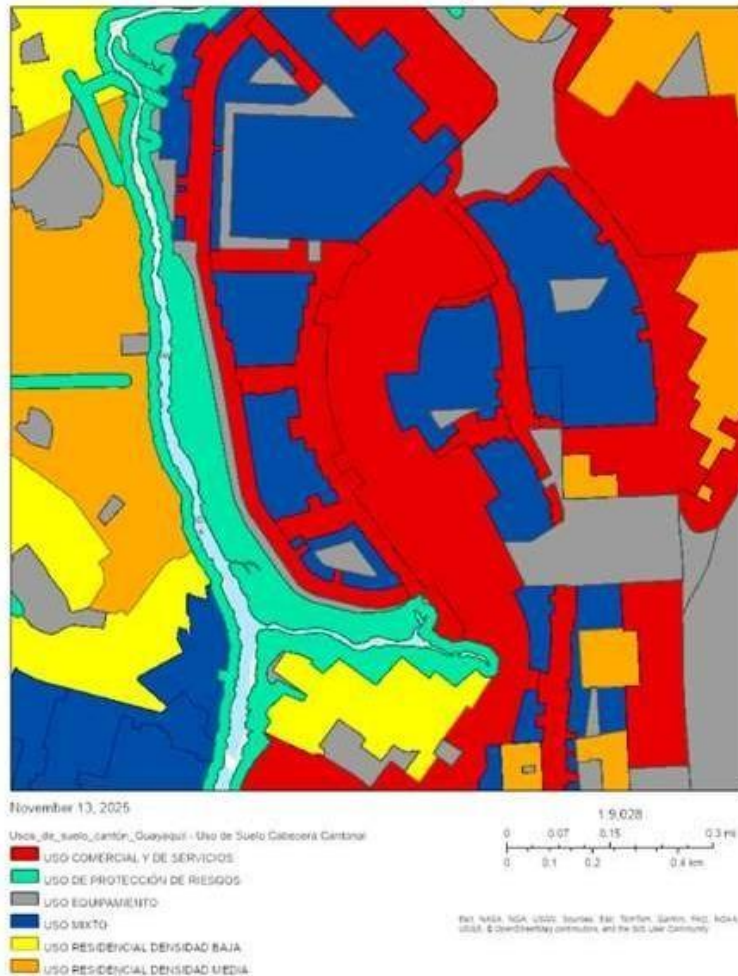
*Figure 2 Land Use and Occupation Map*

The hydrography was determined by the presence of the Estero Salado, which is the main body of water in contact with the study area. The soils were predominantly alluvial, with high waterproofing due to intensive urbanization. Vegetation cover was reduced to less than 15% of the territory, distributed in remaining green areas and small urban parks. Among the most relevant natural hazards were urban flooding due to deficiency in storm drainage and the urban heat island derived from the loss of vegetation.

Loss of vegetation cover: Approximately 85% of the territory was occupied by buildings and pavement, which significantly reduced the absorption capacity of the soil. The disappearance of community green areas and their replacement by commercial buildings was observed.

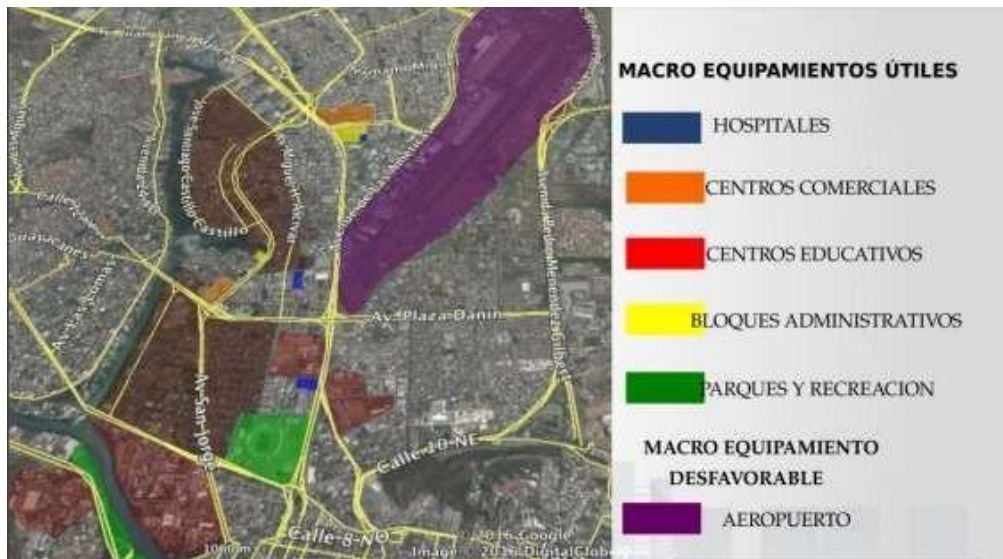
Figure 3 Map of Urban Facilities

Kennedy Norte is a fully consolidated settlement, with modern buildings of medium and high rise. Traditional homes have been transformed to adapt to commercial use, which has changed the residential identity of the sector. Basic services are available, although storm drainage showed capacity problems.

The street furniture fulfills its function, although it is insufficient for the volume of people who pass through daily. The lack of appropriate public spaces and considerable green areas was one of the most problematic aspects within this subsystem.
